SeaTerra surveys and clears UXO contaminated areas on land and on water. We are specialized on windfarm areas and cable routes: Around 10.000 hectares seabed of the North Sea and Baltic Sea were investigated and declared free of unexploded ordnance (UXO)

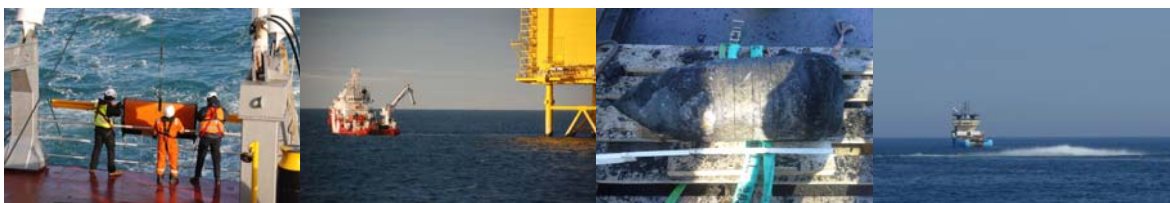
Picture (left to right):

UXO survey. Preparation of the scanfish system.

Target investigation inside the safety zone of the converter platform DolWin alpha.

UXO on board of the clearance vessel, ready to transport onshore.

Detonation after installation of the bubble curtain.

The non-transportable ordnance (50 items, mostly sea mines) was demolished in situ by explosives specialists and ordnance divers of SeaTerra GmbH. All demolitions were thoroughly prepared and designed in close cooperation with the responsible regulators. Marine mammals were protected by scaring devices and a "Big Bubble Curtain" to minimize noise.

A special feature was the geophysical investigation within the 500 m safety zone of the existing converter platform DolWin alpha. The work was carried out under the highest safety requirements and only under ideal weather conditions.
